ECOLOGICAL STUDY FOCUSED ON POST POND WATER LEVEL

November 2008

**Study Conducted for the
Lyme Conservation Commission**

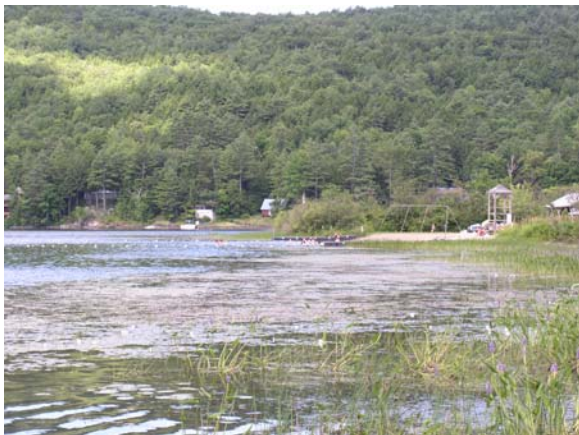
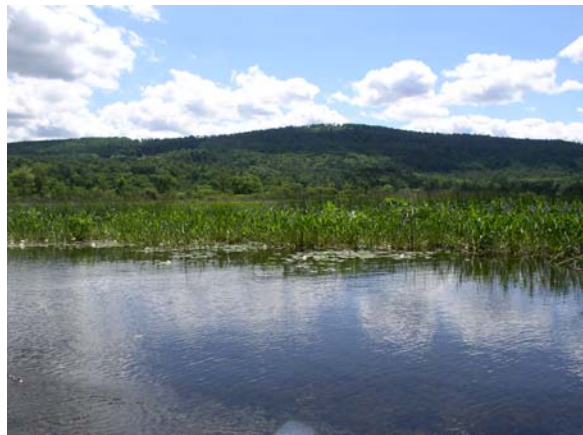
These two pictures show the multi-faceted considerations for management of water levels on Post Pond: public access, use and housing; as well as rich, diverse wildlife habitat.

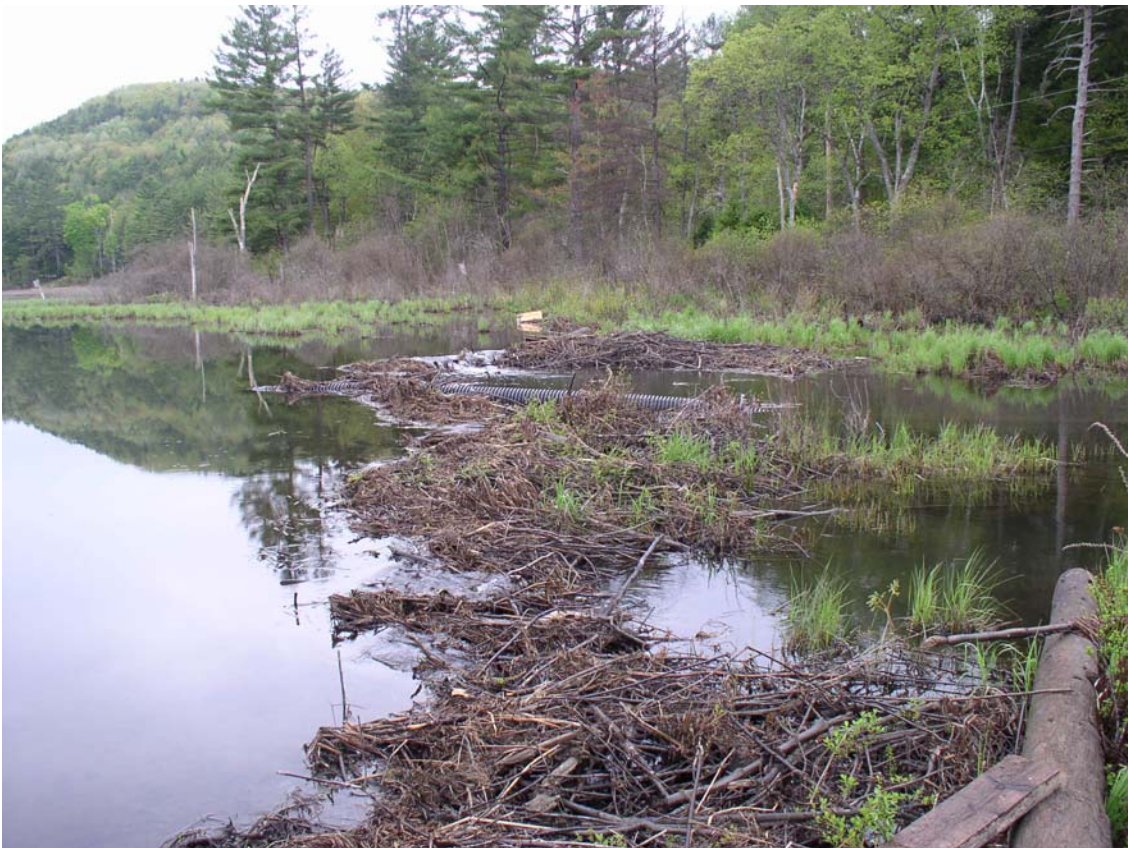
Beaver dam is unmaintained and breached, resulting in lower water levels in Post Pond. There was very little fresh beaver sign during three site visit in 2008.

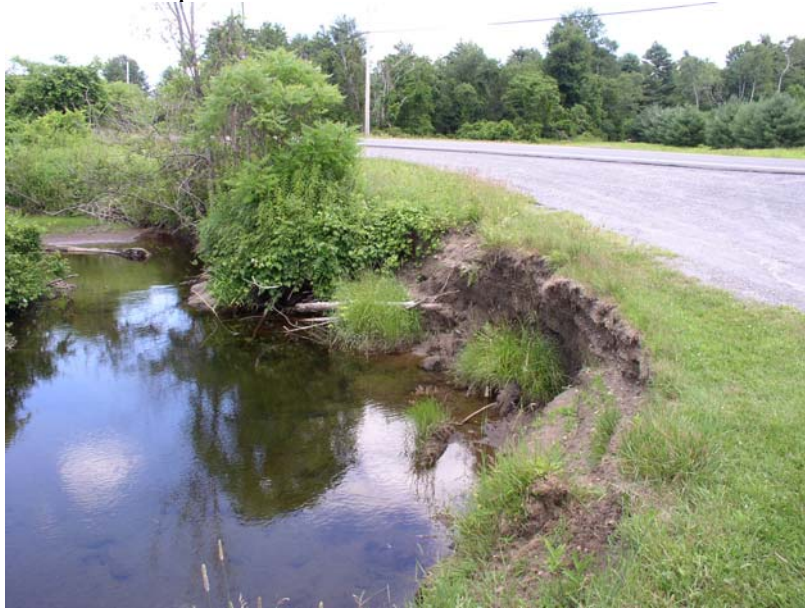
A potential safety concern: Trout Book is undercutting the bank along a pull-off on Route 10.

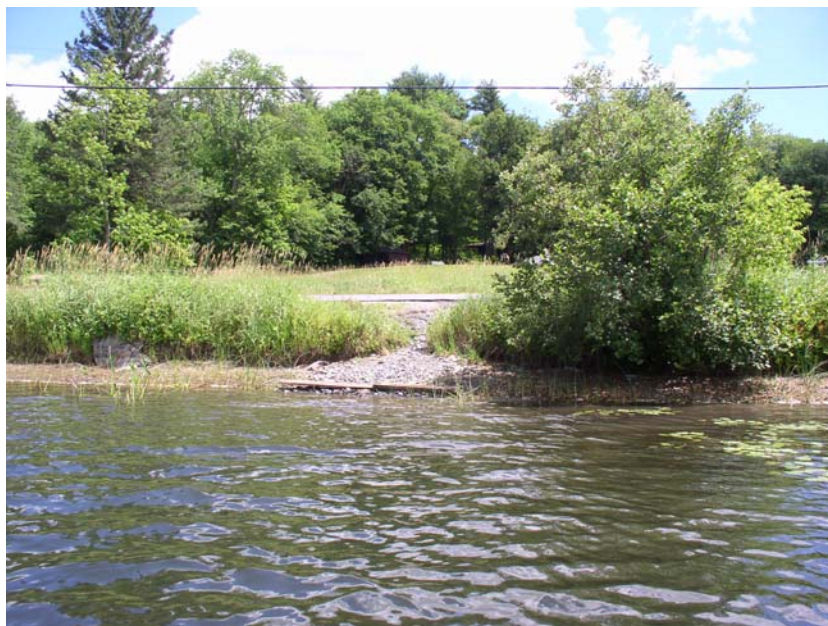
Route 10's shoulder is very close to the edge of Post Pond at this location.

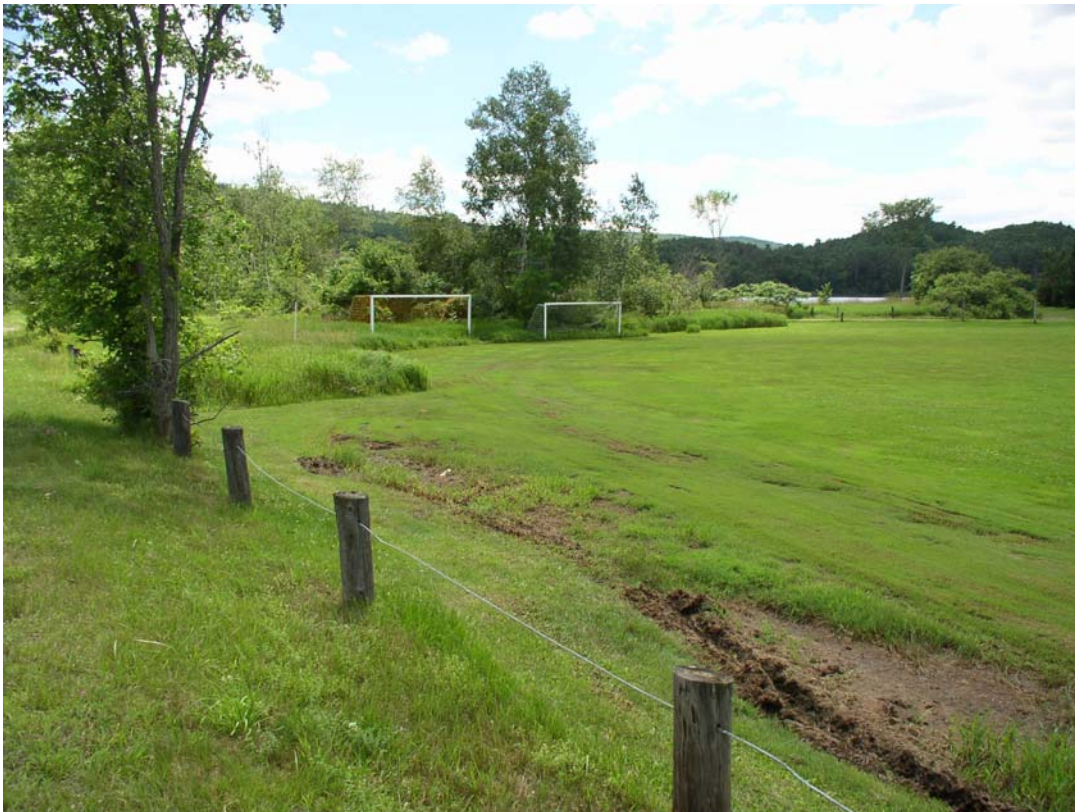
Ruts in the athletic field expose dark, organic, hydric soils, which remained very wet during all three site visits.

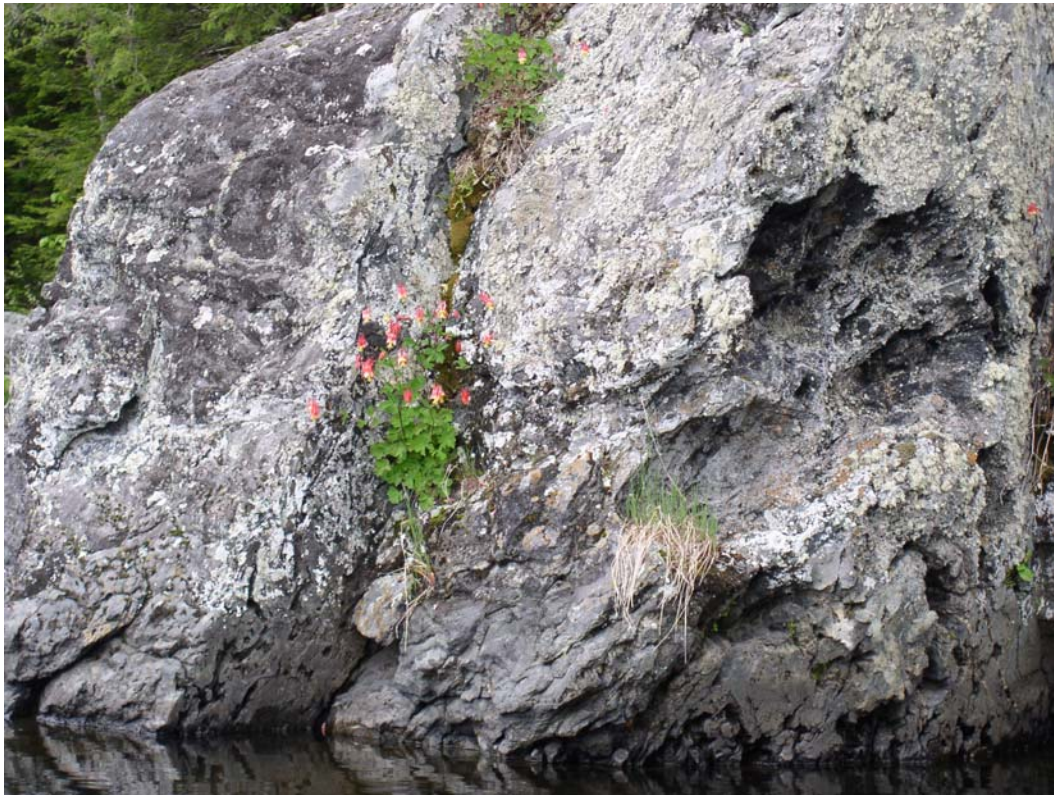
The variation of weathering on this boulder illustrates the different chemical compositions and minerals that make up this rock.

There are several homes, camps, and water access points around the shoreline of Post Pond. Due to the rugged topography and exposed ledge, the shoreline is stable and relatively unaffected by the water level of Post Pond. The composition of the exposed rock and ledge creates an interesting erosion pattern where the harder, granitic rock displays relatively slow

wear from the wave action and freeze/thaw cycles, while the softer calcareous rock displays pockets or pouch marks of erosion giving the shoreline a very irregular look.

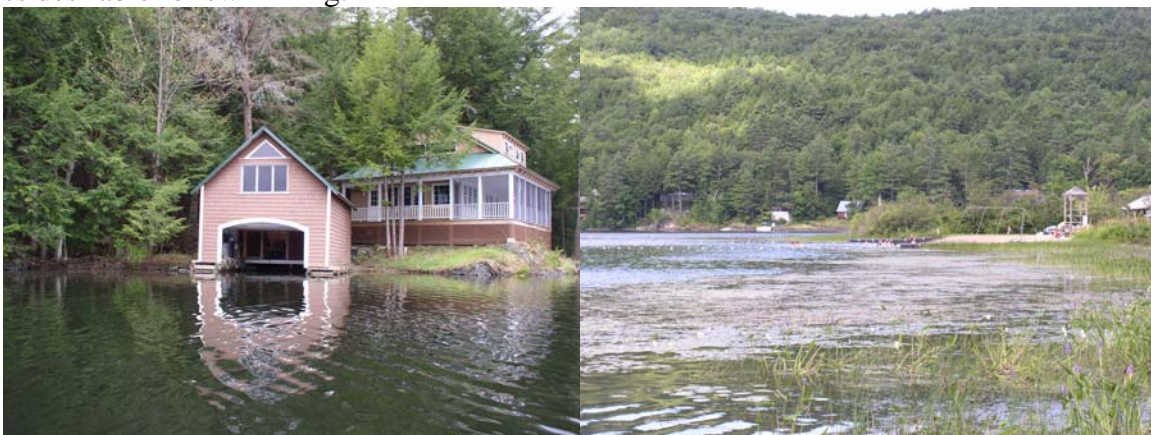
Houses, boat houses and public beaches are affected by greatly fluctuating water levels.

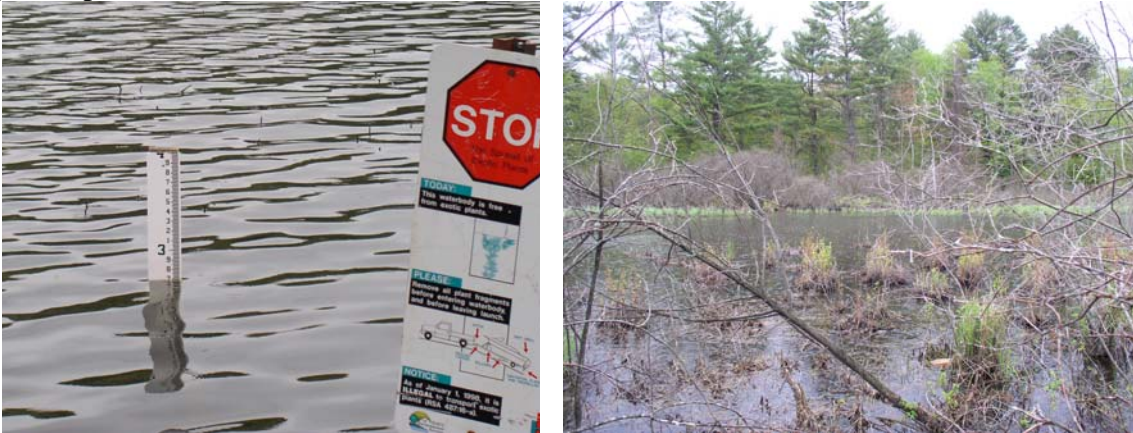
May 15, 2008 Site visit. The left photo shows the water level at the marker and the right photo shows water stained leaves indicating that water levels had been higher recently.

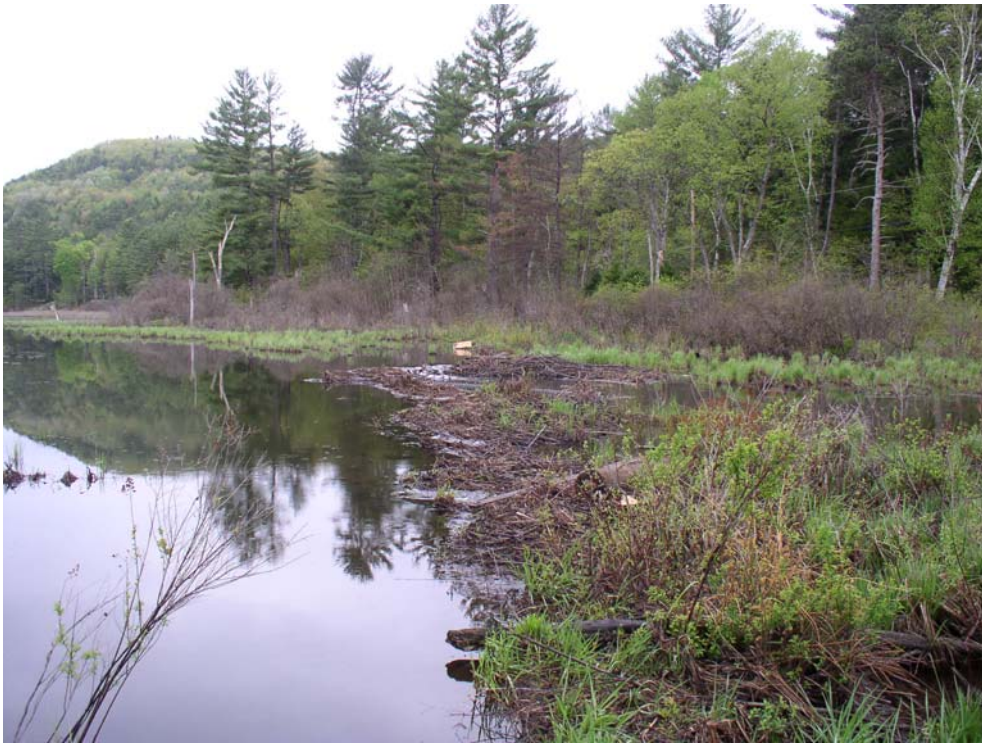
The lower beaver dam on Clay Brook has deteriorated due to lack of active beaver maintenance, but still controls the water level in the study area with respect to the spring high water table and runoff effects.

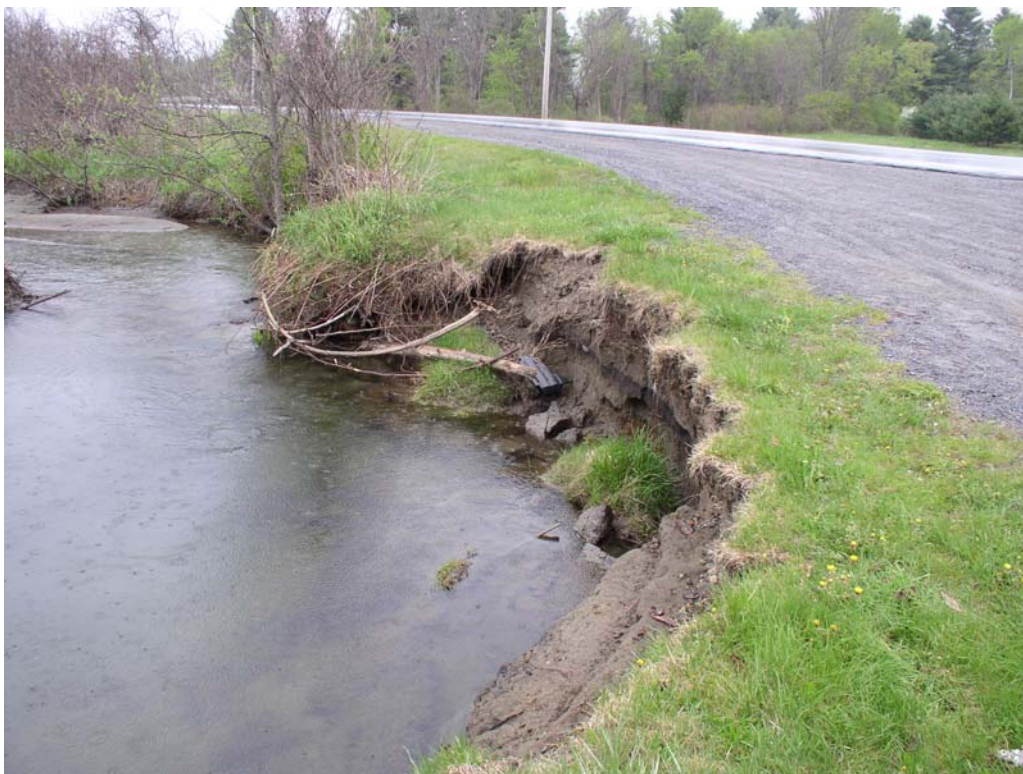
Trout Brook along the Rte. 10 pull-off area just north of Balch field has meandered on this reach causing severe erosion. It is a safety concern for the highway.

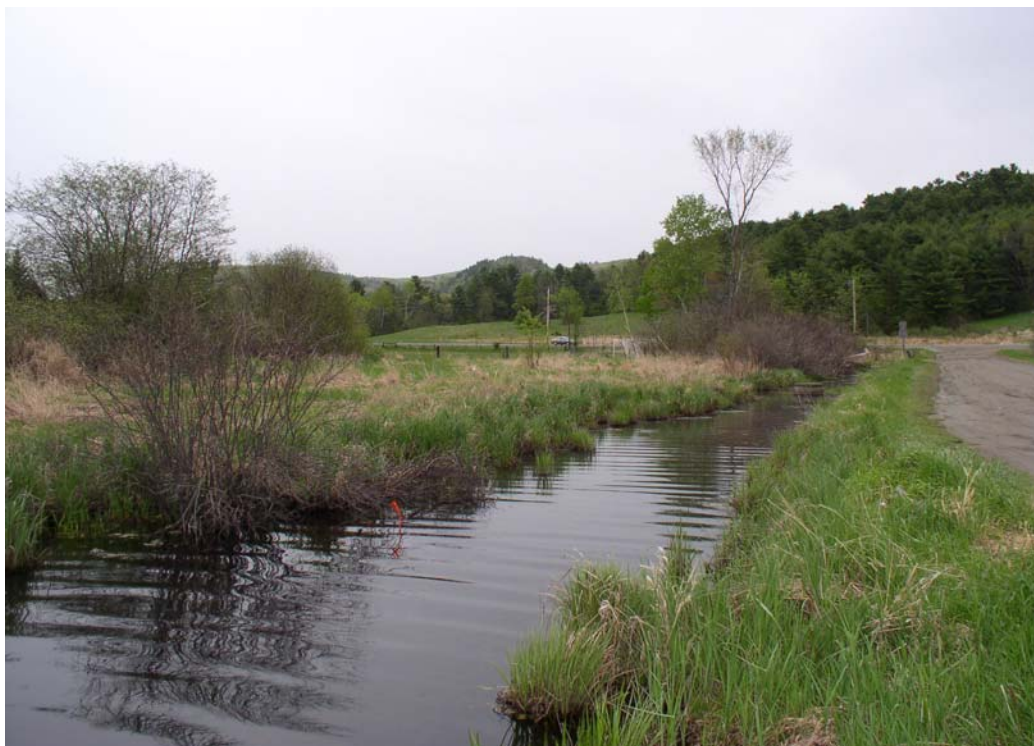
The southeastern section of the athletic field along Rte. 10 is extremely wet at this time of year and contains several hydrophytic species of plants. Because of the small elevation change, the man-made ditch alone will not resolve this issue.

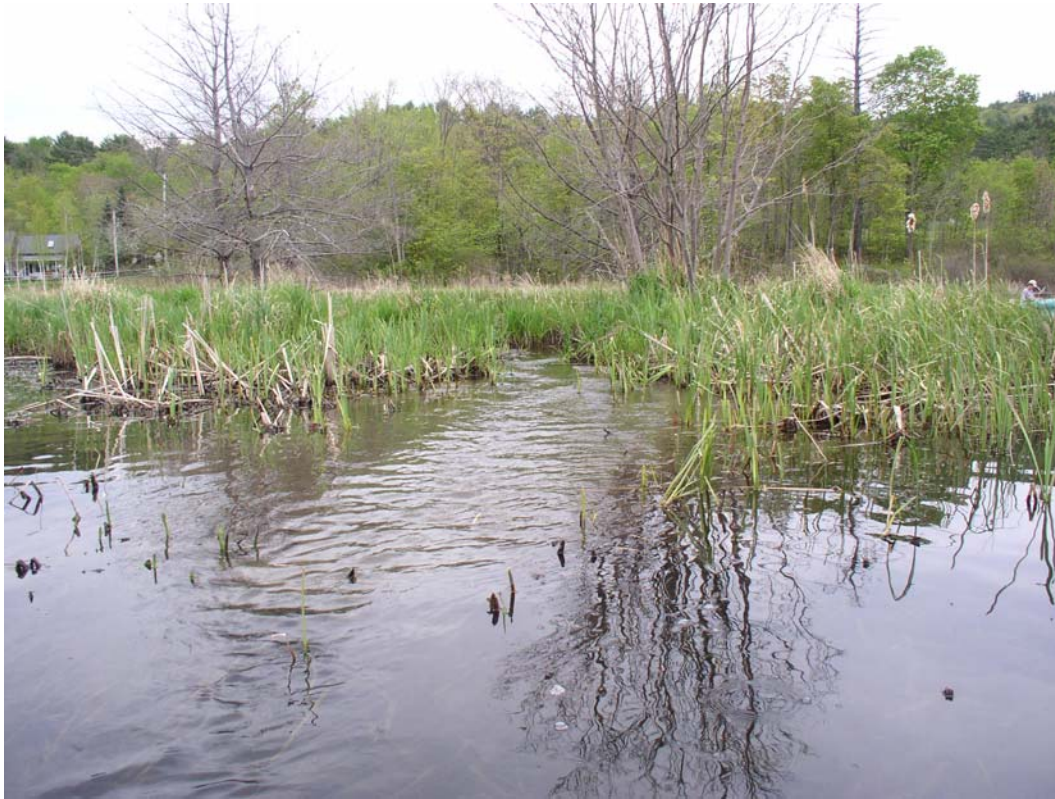
In addition to Trout Brook, six small tributaries were located entering Post Pond. Please refer to the attached map in the back of this report.

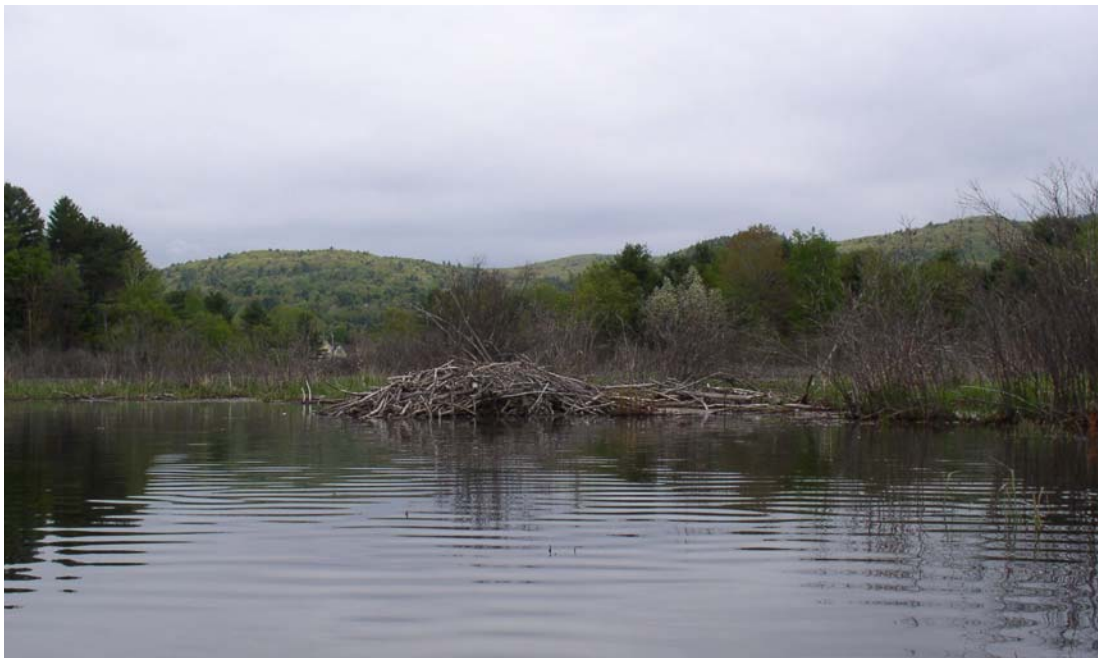
Several beaver lodges of varying vintage were documented in the study area.

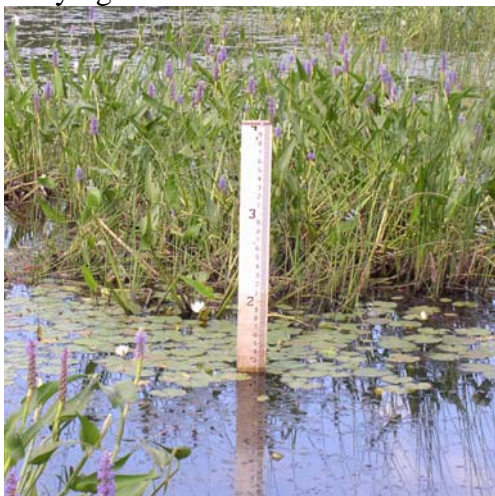
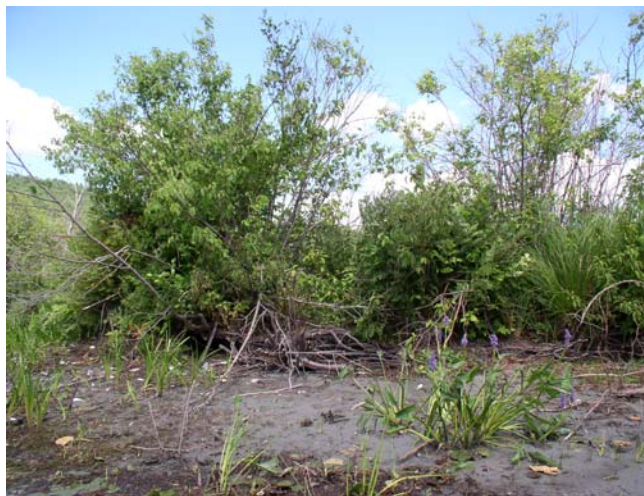
The left photo shows the water level at the marker in Post Pond, and the right photo shows the effects of lower water levels on some of the plant species.

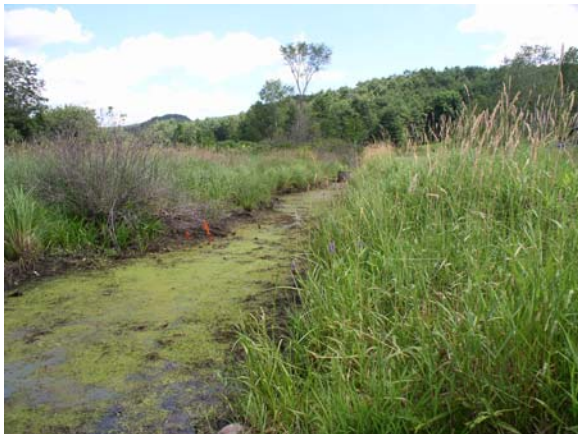
Drainage ditch at very low water

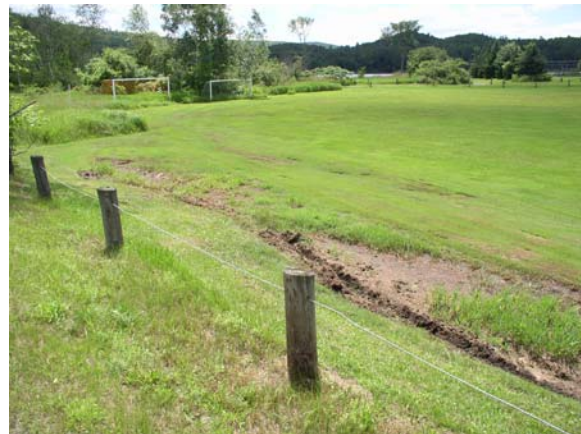
The athletic field remains wet

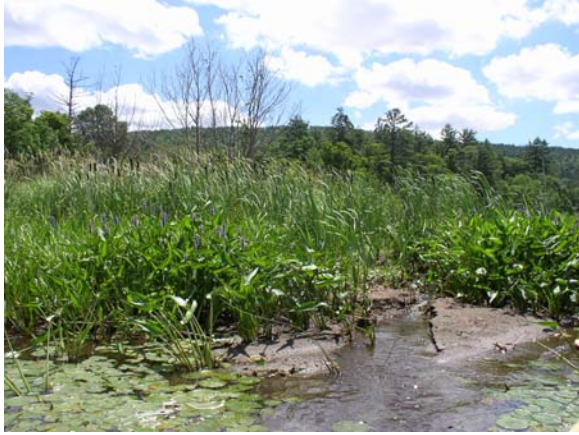
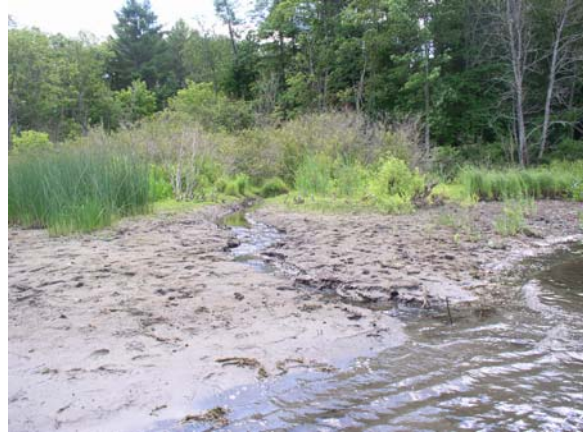
All six of the small tributaries continue to flow, suggesting that they are all perennial streams. Two are shown here.

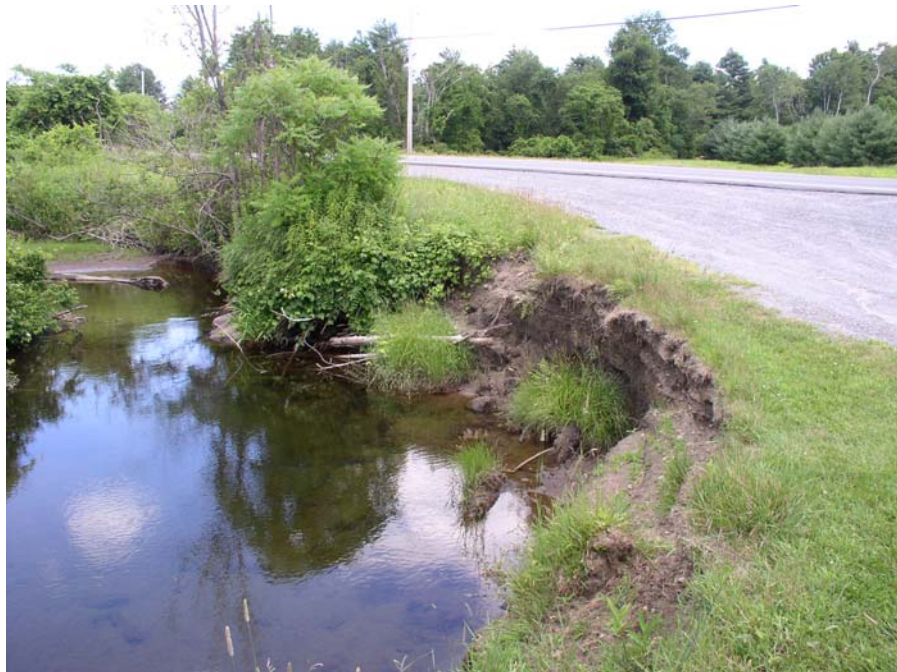
The streambank erosion on Trout Brook has not worsened during the summer rains, but vegetation has not stabilized the bank, particularly where it is undercut.

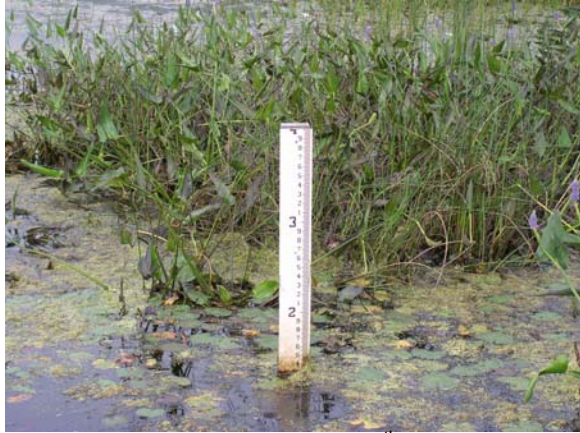
The water level during August 28th site visit

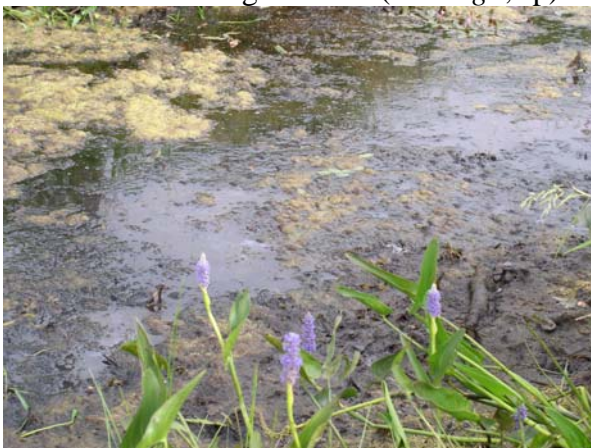
Algae – low water, late summer

- abundant algae growth, most abundant was brown jelly mass, (similar to frog egg mass after hatch)
- bindweed (*Convolvulus sepium*)
- sumac
- goldenrod (*Solidago*, sp)

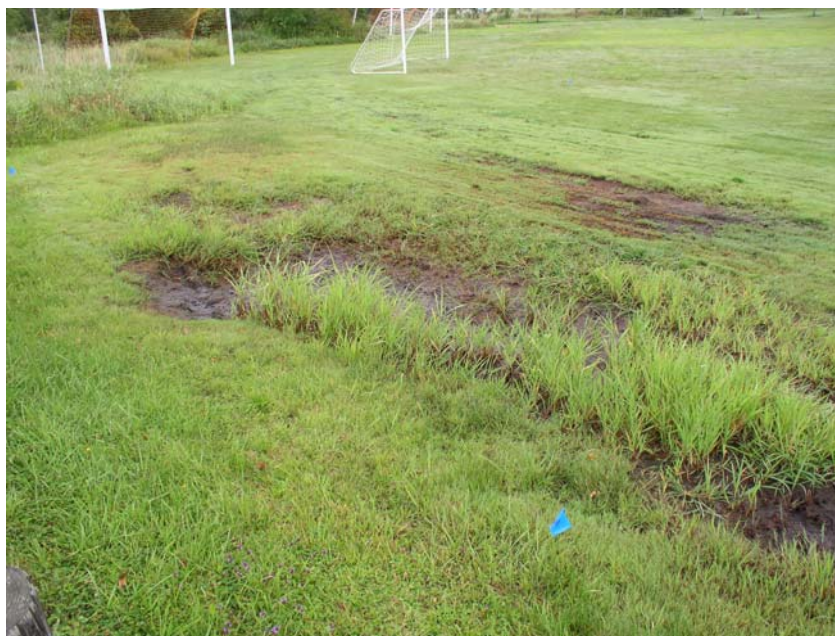
The athletic field continues to hold water and grow wetland plant species.

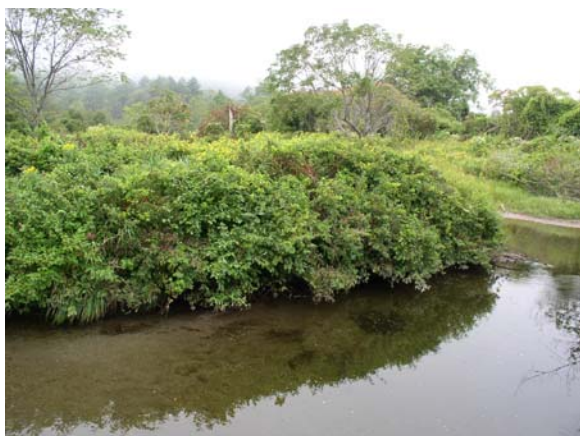
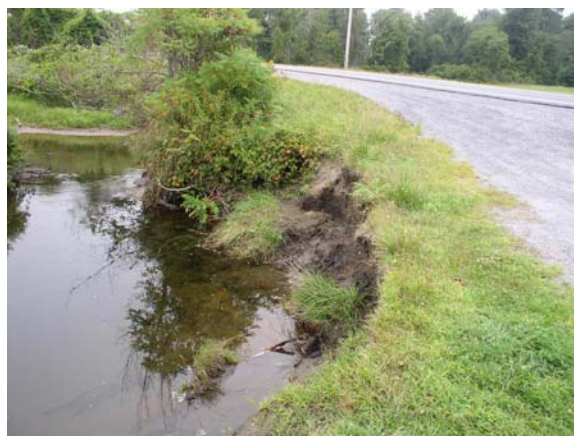
Bindweed in flower, sumac, goldenrod, lush riparian growth on opposite side of Trout Brook erosion site near Rte. 10 pulloff; vegetation will need some active help to stabilize the streambank beside Rte. 10.

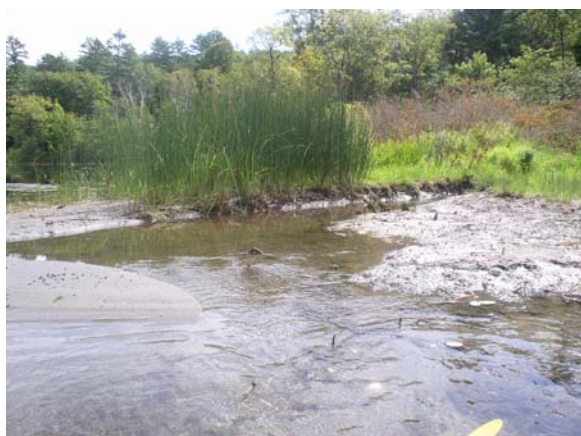
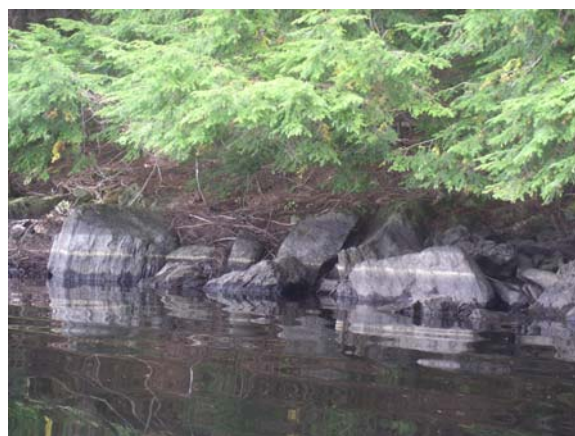
Left photo: All of the small perennial streams feeding into Post Pond maintain a good flow.
Right photo: Well marked normal water level
